Jul 3rd, 2026

123 Main Street, Manassas, VA 20112

# Residential Home Inspection

Jeffrey Middleton / Casa 360 Home Inspections

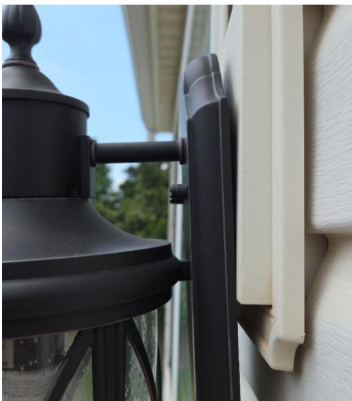
The exterior light on the back porch is loose. This can allow water to get behind the siding though the mounting hole. Recommend repair by a qualified contractor.

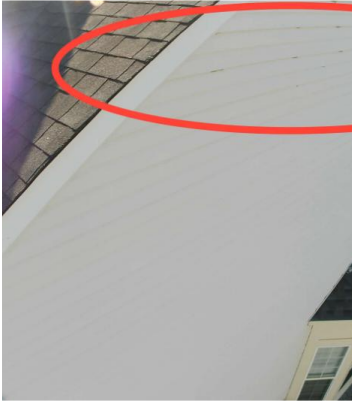
### Vinyl Siding – Buckled

During the inspection of the siding on the exterior of the home, siding panels were noted at the side of the house (SouthWest side) that appeared to be buckled. While there are many reasons siding can appear buckled, most commonly this buckling is associated with thermal expansion. High temperatures can cause the panels to expand; if the panels are not installed properly, they become more prone to buckling or warping. This can happen when panels are not properly spaced to allow for expansion and contraction. It is recommended that a qualified contractor familiar with composite siding installation and repair methods further evaluate to determine if the siding buckling is merely a cosmetic defect or a defect that requires correction and repair.

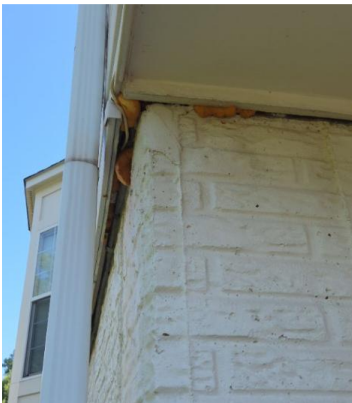
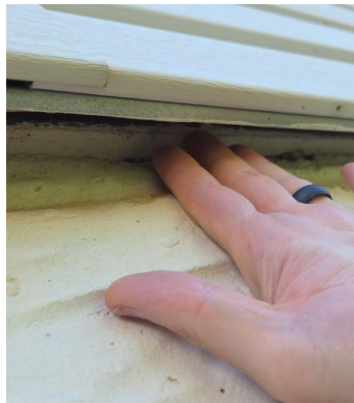
### siding to foundation – Non-Professional Repairs

A previous repair to the siding where it meets the white painted masonry wall foundation looks to be a non-professional repair. A visible gap where the siding meets the top of the foundation is present and no obvious flashing. This can result in moisture penetration and pest intrusion. Recommend this be repaired by a qualified siding contractor.

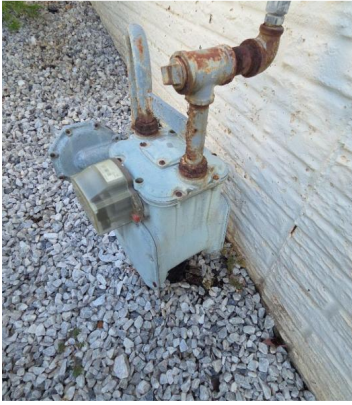
Heavy rust present at Gas Meter but no apparent signs of leaks.

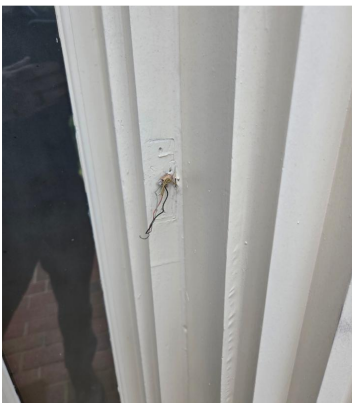
Hardwired doorbell has exposed wires. Located next to a smart doorbell. Low voltage current but recommend correcting by contractor.

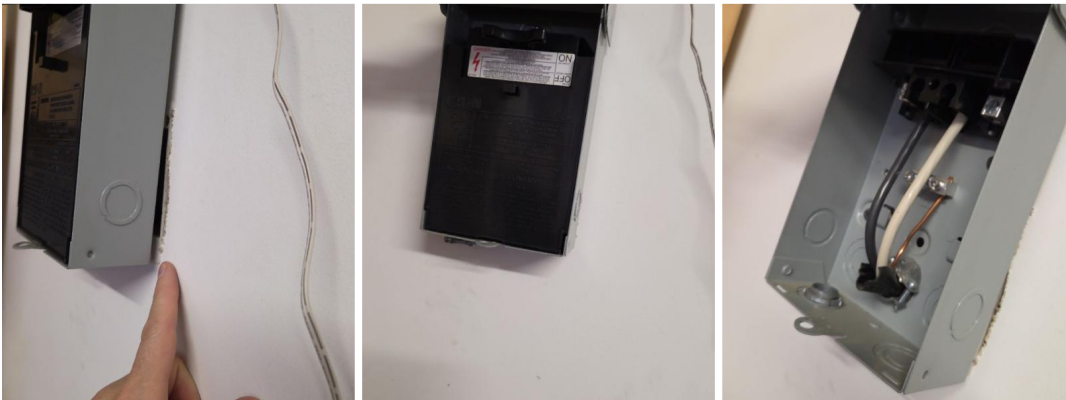
Recommend a contractor seal the gap on the side of the 220 breaker in garage.

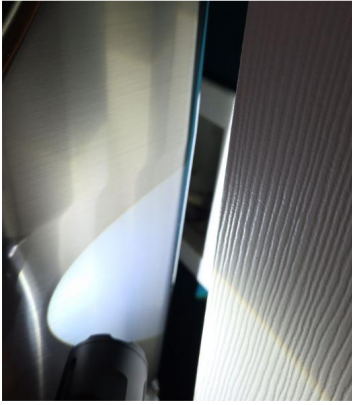
The laundry supply lines were inaccessible based on the position of the washer and dryer. Access to the water supply lines in the event of an active leak is needed. Recommended reconfiguring the layout to ensure access to the water supply lines if possible.

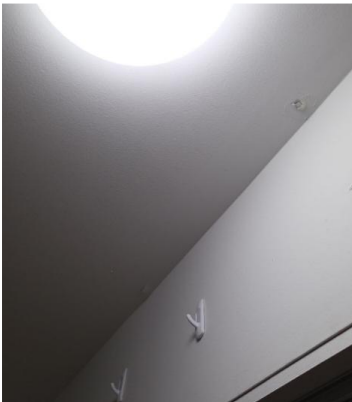
##### Drywall - Nail Pops

Nail pop(s) were observed at the time of the inspection on the ceiling of one of the two walk-in closets. A nail pop is a drywall defect where the nail or screw head has lifted or broken through the paint layer. These nail pops are often the result of seasonal expansion/contraction or minor structural settlement. At the discretion of the buyer, a qualified contractor make the necessary repairs.

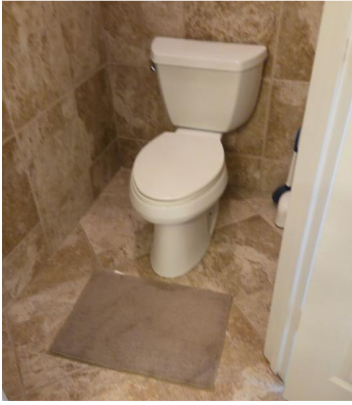
Toilet is loose from the floor. Recommend securing to prevent leaking/water damage.

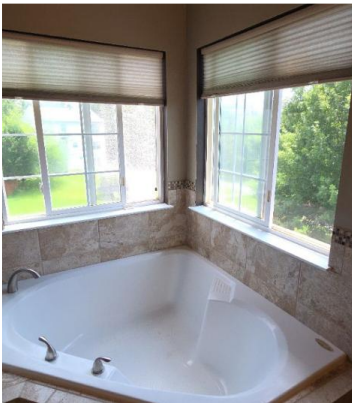
Caulk edge(s) of tub/surround

Caulk around tub surround is old and deteriorated. This can allow water infiltration and deterioration of framing around the tub. Recommend removing old caulk around tub and apply new caulk.

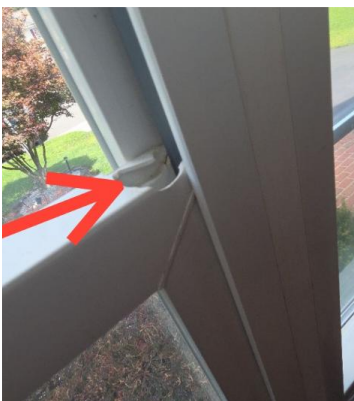
Window damaged

The window in the front room in the photo was damaged. Recommend correction by a window contractor.

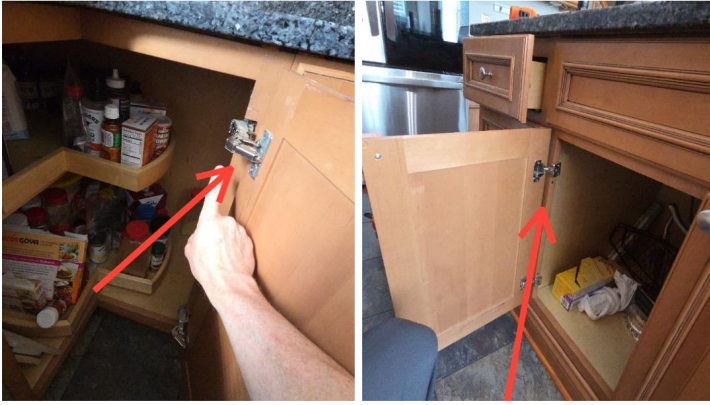
Cabinet door hinge(s) needs tightening/adjustment or replacement.

Cabinet door hinge(s) needs tightening/adjustment or replacement by a contractor. One location was the Corner lower cabinet and the other was the under-stove cabinet.

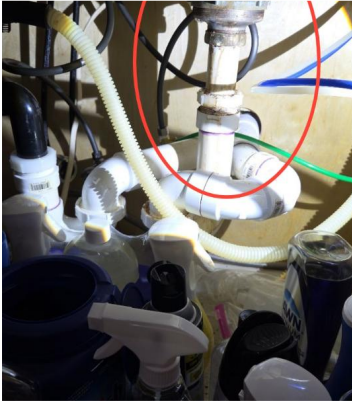
Plumbing Drainpipe – possible previous leak

The plumbing drainpipe under the kitchen sink appears to have had a leak at some point. Recommend monitoring for future leaks.

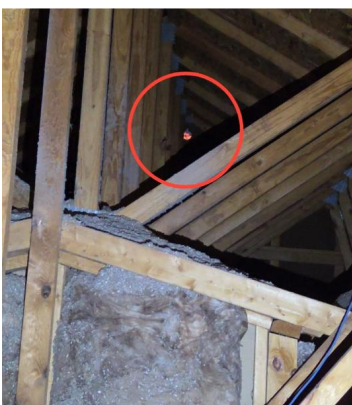
The gable vents appear to be decorative from the exterior since the house has a ridge vent. They also appear to be closed from the attic. However, the gable vents have torn or missing cover materials when viewed from the attic.

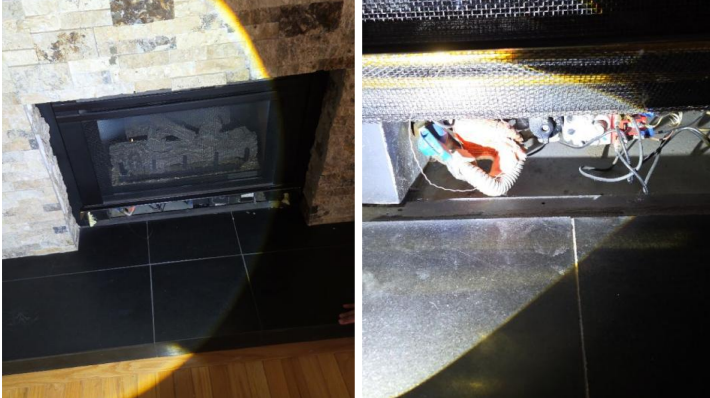
Gas Fireplace Not Tested – Control missing or inoperable

The indicated gas set could not be tested at the time of the inspection because the unit's dial to control gas flow was missing. The pilot light was on. Recommended repair by a licensed gas contractor.

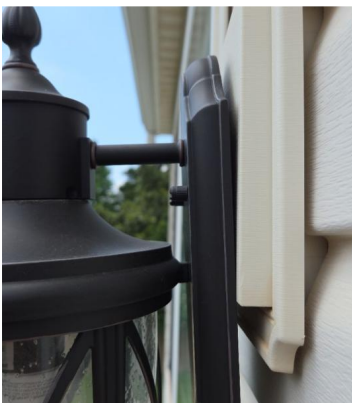
The exterior light on the back porch is loose. This can allow water to get behind the siding though the mounting hole. Recommend repair by a qualified contractor.

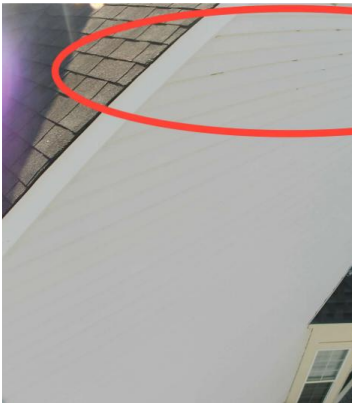
#### Vinyl Siding – Buckled

During the inspection of the siding on the exterior of the home, siding panels were noted at the side of the house (SouthWest side) that appeared to be buckled. While there are many reasons siding can appear buckled, most commonly this buckling is associated with thermal expansion. High temperatures can cause the panels to expand; if the panels are not installed properly, they become more prone to buckling or warping. This can happen when panels are not properly spaced to allow for expansion and contraction. It is recommended that a qualified contractor familiar with composite siding installation and repair methods further evaluate to determine if the siding buckling is merely a cosmetic defect or a defect that requires correction and repair.

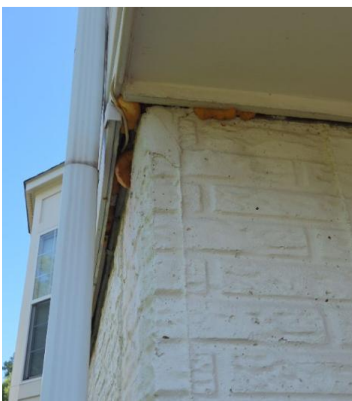
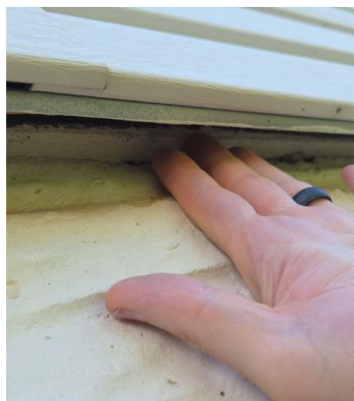
#### siding to foundation – Non-Professional Repairs

A previous repair to the siding where it meets the white painted masonry wall foundation looks to be a non-professional repair. A visible gap where the siding meets the top of the foundation is present and no obvious flashing. This can result in moisture penetration and pest intrusion. Recommend this be repaired by a qualified siding contractor.

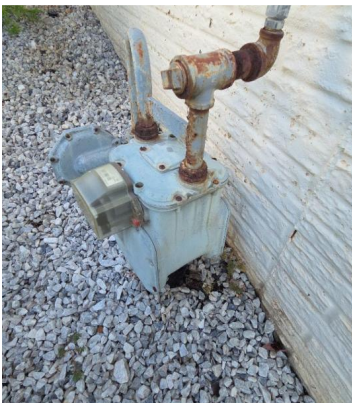
Heavy rust present at Gas Meter but no apparent signs of leaks.

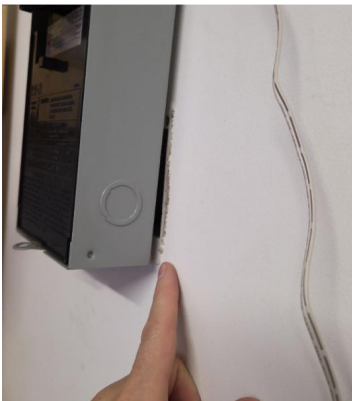
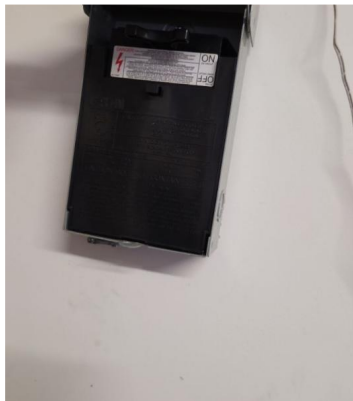
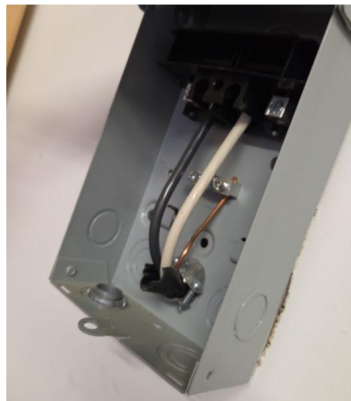
Recommend a contractor seal the gap on the side of the 220 breaker in garage.
