Aug 3rd, 2026

123 Central Street, Alexandria, VA 22302

# Residential Home Inspection

Jeffrey Middleton / Casa 360 Home Inspections

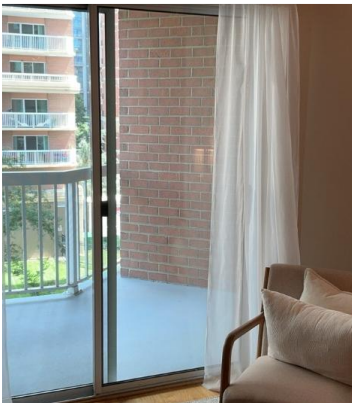
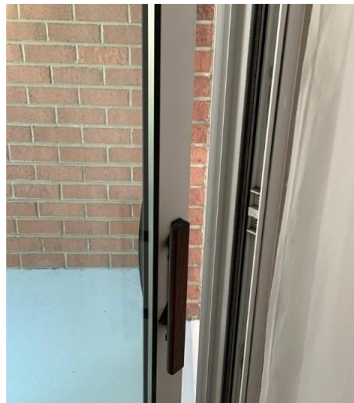
## 2.4 PATIO DOOR

Patio door does not lock

The sliding glass patio door would not lock. This is a safety concern for unauthorized entrance into the home. Recommend repair by a qualified handyman.

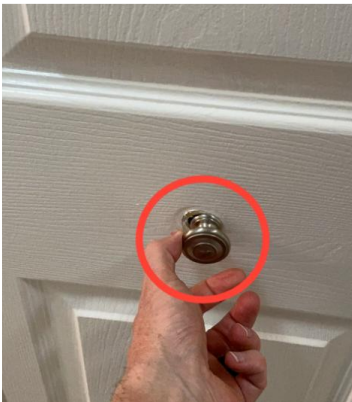
## 5.2 LOCATION

Laundry closet door handle incorrectly installed.

The door for the laundry room closet (in the bathroom) was installed incorrectly or has become loose over time. Recommend correction by a handyman.

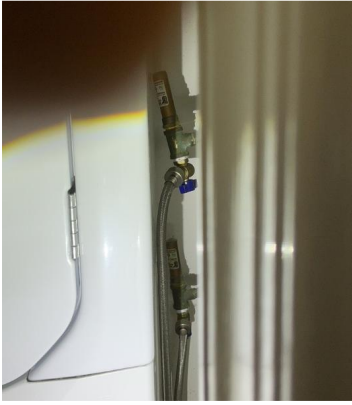
## 5.4 WASHER HOSE BIB

Unable to access washing machine shut-off valve.

Based on the position of the stacked washer/dryer unit, it is difficult, if not impossible, to operate the shut-off valve for the washing machine. This can be an issue if the water to the machine ever needs to be turned off in an emergency. Recommend contacting a licensed plumber for evaluation.

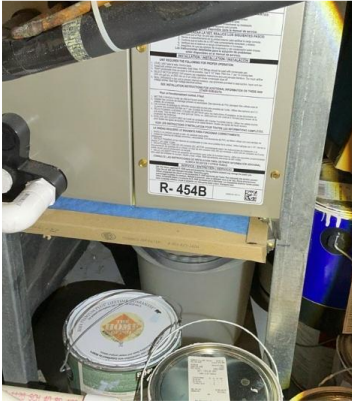
## 6.7 BLOWER FAN/FILTERS

**Wrong Size Filter**

The return air filter of the indicated HVAC unit was not properly sized. It is crucial to the indoor air quality of the home and the overall functionality/lifespan of the HVAC unit that the air filters be properly maintained. Although the filter was too long, it does allow for the filter to be grabbed in order to remove it from the unit.

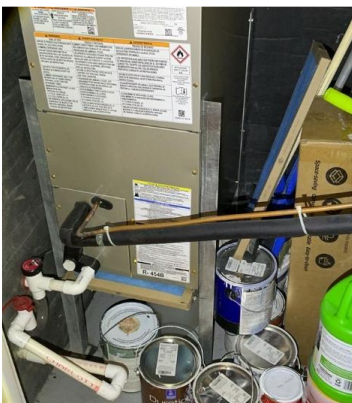
Location - In HVAC Closet

Clean HVAC P-trap cleaning and maintenance kit brush

The brush used to clean the HVAC P-trap cleaning and maintenance kit (most commonly known as a condensate trap kit or a smart trap kit) needs to be cleaned of debris. The clear plastic and PVC assembly feature a removable cap, cleaning brush, and optional shut-off float switches to allow for cleaning of the HVAC condensate p-trap. Recommend routing cleaning of the p-trap as well.

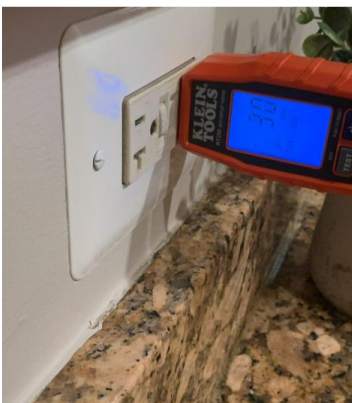
## 7.2 ELECTRICAL

Replace faulty GFCI outlet

Replace faulty GFCI outlet in kitchen to the left of sink. Showed 'Open Neutral' at the time of testing as shown in photo.

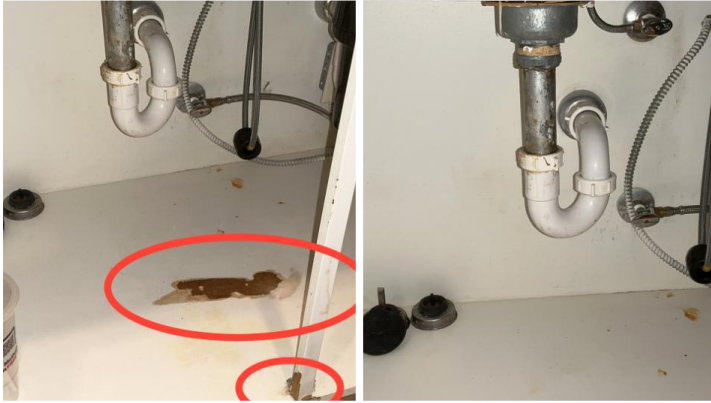
Location - Kitchen

Previous leak under sink and cabinet damage.

Evidence of a previous leak and damage to the cabinet bottom seen inside the kitchen cabinet under the sink at the time of the inspection. This does not appear to be an active leak. Rec-

ommend evaluation by a plumber or handyman for the p-trap and sink drain connection and monitoring for future leaks. Recommend repairing current damage to the bottom of the cabinet to restore the paint barrier for future protection for items placed within the cabinet.

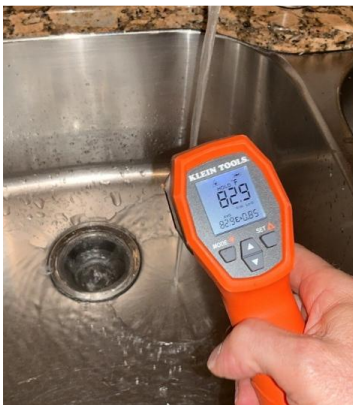
Water at sink not hot or slow to get hot.

The hot water at the kitchen faucet took at least 5 minutes to get hot. After running the water for 5 minutes, the temperature stayed below 83 degrees F. After testing again and letting it run, it reached normal temperature.

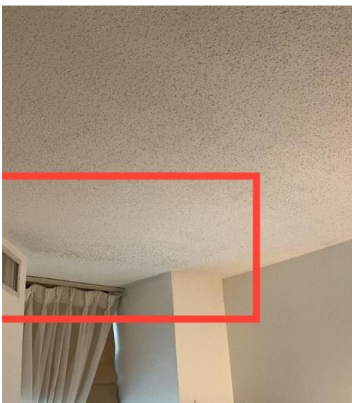
### 8.3 CEILING

Debris on ceiling near vent.

Debris or dirt seen at the time of the inspection on the ceiling immediately next to the air conditioning vent in the bedroom ceiling. Recommend cleaning and monitoring.

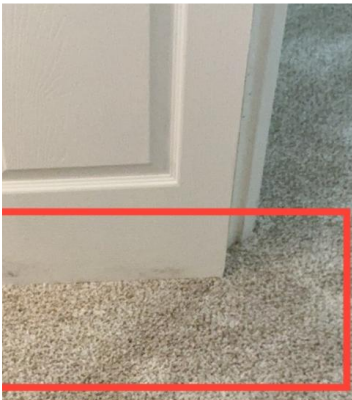
## 8.10 CLOSET

Closet Door rubs carpet when operating.

The indicated closet door (left door as seen from Bedroom) rubs the carpet when opening/closing. This can cause premature wear to the carpet over time. Recommend the bottom of the door be cut to allow for free movement along the carpet.

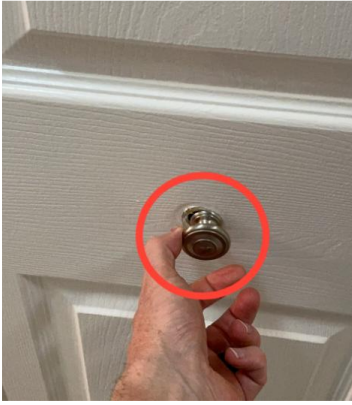
### 5.2 LOCATION

Laundry closet door handle incorrectly installed.

The door for the laundry room closet (in the bathroom) was installed incorrectly or has become loose over time. Recommend correction by a handyman.

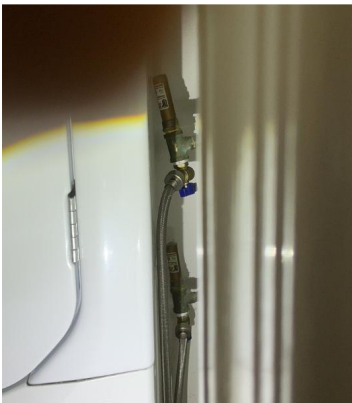
#### 5.4 WASHER HOSE BIB

Unable to access washing machine shut-off valve.

Based on the position of the stacked washer/dryer unit, it is difficult, if not impossible, to operate the shut-off valve for the washing machine. This can be an issue if the water to the machine ever needs to be turned off in an emergency. Recommend contacting a licensed plumber for evaluation.

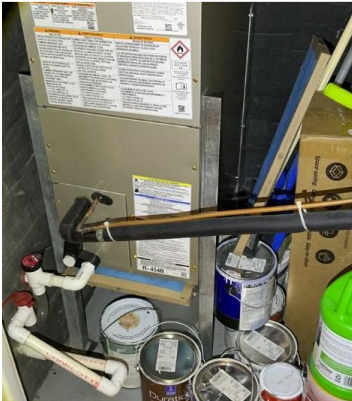
Location - In HVAC Closet

Clean HVAC P-trap cleaning and maintenance kit brush

The brush used to clean the HVAC P-trap cleaning and maintenance kit (most commonly known as a condensate trap kit or a smart trap kit) needs to be cleaned of debris. The clear plastic and PVC assembly feature a removable cap, cleaning brush, and optional shut-off float switches to allow for cleaning of the HVAC condensate p-trap. Recommend routing cleaning of the p-trap as well.

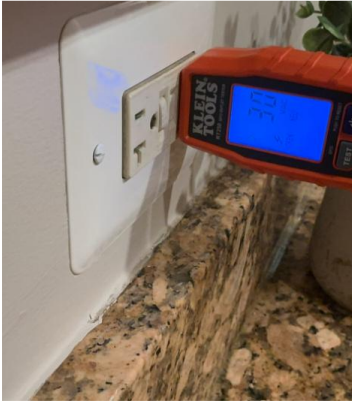
### 7.2 ELECTRICAL

Replace faulty GFCI outlet

Replace faulty GFCI outlet in kitchen to the left of sink. Showed 'Open Neutral' at the time of testing as shown in photo.

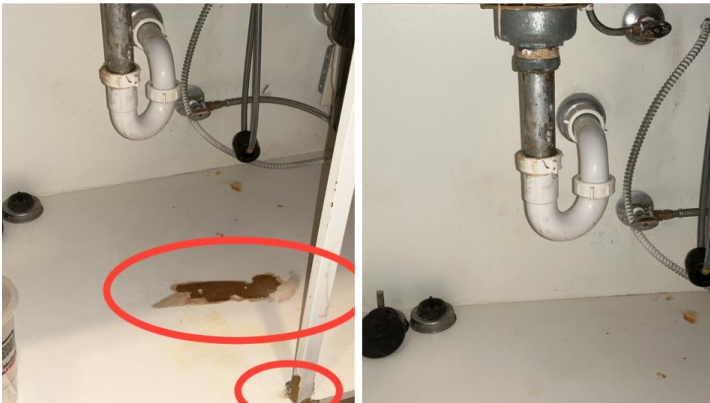
Location - Kitchen

Previous leak under sink and cabinet damage.

Evidence of a previous leak and damage to the cabinet bottom seen inside the kitchen cabinet under the sink at the time of the inspection. This does not appear to be an active leak. Recommend evaluation by a plumber or handyman for the p-trap and sink drain connection and monitoring for future leaks. Recommend repairing current damage to the bottom of the cabinet to restore the paint barrier for future protection for items placed within the cabinet.

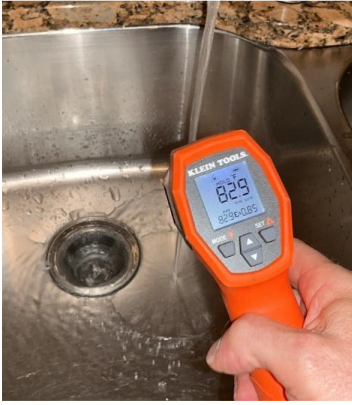
Water at sink not hot or slow to get hot.

The hot water at the kitchen faucet took at least 5 minutes to get hot. After running the water for 5 minutes, the temperature stayed below 83 degrees F. After testing again and letting it run, it reached normal temperature.

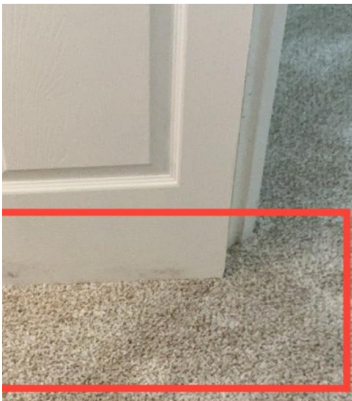
### 8.10 CLOSET

Closet Door rubs carpet when operating.

The indicated closet door (left door as seen from Bedroom) rubs the carpet when opening/closing. This can cause premature wear to the carpet over time. Recommend the bottom of the door be cut to allow for free movement along the carpet.
