Jul 3rd, 2026

123 Main Street, Manassas, VA 20112

# Residential Home Inspection

Jeffrey Middleton / Casa 360 Home Inspections

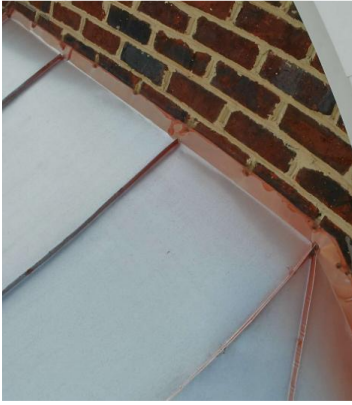
Bare Standing Seam Metal Roof

The front porch was roofed with a style of metal roofing commonly known as “standing seam” metal roofing. A standing seam metal roof typically has a lifespan of 40 to 50 years whereas an exposed fastener metal roof typically has a lifespan of 20 to 25 years. This metal is currently bare and can rust if not periodically painted with a quality exterior paint.

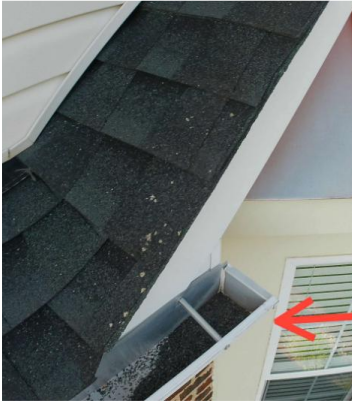
Asphalt granules in gutters

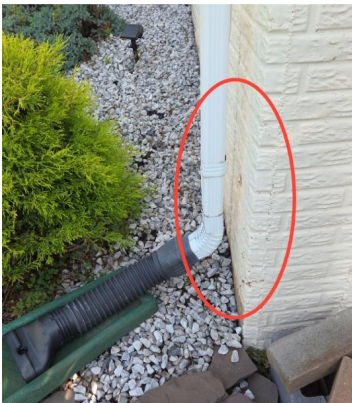
Downspout component Loose

The indicated section of downspout was loose. (Location detailed within the report photos) It is recommended that the loose downspout section be repaired or secured as needed by a qualified contractor.

Requires Attention

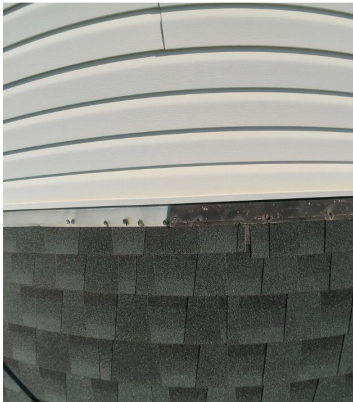
Metal flashing was present at the roof-to-wall intersection on the front of the house above the garage. Exposed fasteners were observed in the flashing. Recommend maintaining sealant at

exposed fasteners to help reduce the potential for moisture intrusion or repair by licensed roofing contractor.

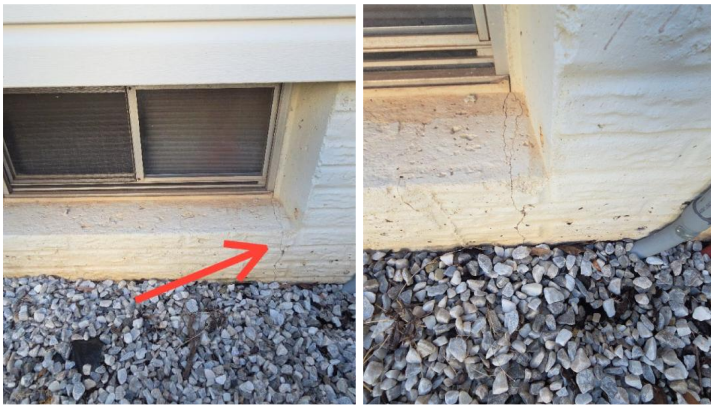
Brick – Cracking Below basement windows - Minor

Minor cracking was noted in the brick of the exterior of the home below the basement windows. This type of cracking is often the result of past settlement or structural movement. It is recommended that ALL cracks within the brick be sealed by a qualified contractor to prevent moisture intrusion into the mortar crack or void. If water is allowed to enter the crack or mortar void prior to freezing temperatures. The water's expansion as it freezes can lead to further deterioration and cracking. During repairs, the use of a cement-based mortar is preferred compared to a flexible sealant such as silicone or caulk. A cement-based mortar repair will allow the repaired crack to be monitored for signs of additional movement or cracking.

Monitor

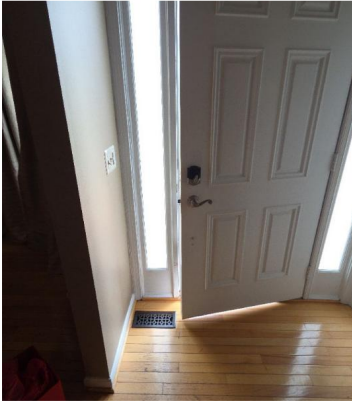
**Location -** Front door

The indicated exterior door was binding on the door frame and as a result would not open and close properly. It is recommended that a qualified contractor make the necessary repairs or adjustments needed to allow the door to open/close properly.

Requires Attention

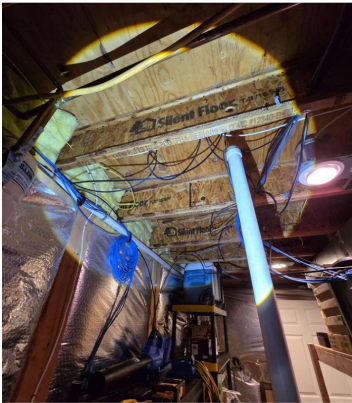
Visible engineered I-joists: OSB web (the middle section) with solid wood or LVL flanges on the top and bottom.

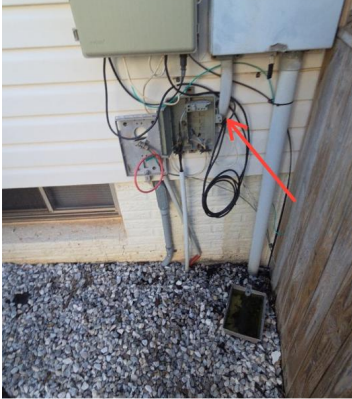
Exterior Holes in siding

The pictured exterior electrical service has an open hole where it enters the home through the siding. This can allow for moisture penetration and pest intrusion. Recommend sealing with 'Duct seal' compound.

Requires Attention

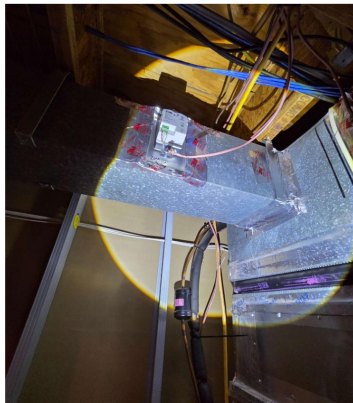
Zone electronic baffle in Basement controlled by thermostat.

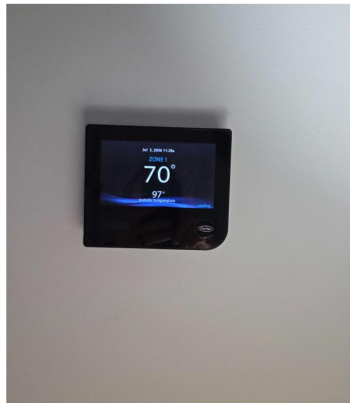
Zone electronic baffle in Basement controlled by thermostat.

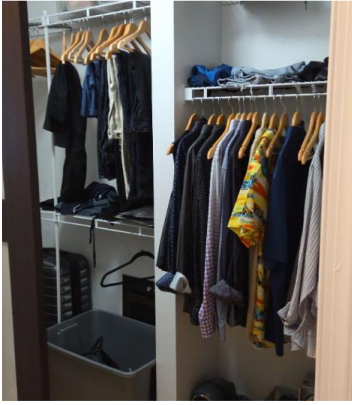
##### Drywall - Nail Pops

Nail pop(s) were observed at the time of the inspection on the ceiling of one of the two walk-in closets. A nail pop is a drywall defect where the nail or screw head has lifted or broken through the paint layer. These nail pops are often the result of seasonal expansion/contraction or minor structural settlement. At the discretion of the buyer, a qualified contractor make the necessary repairs.

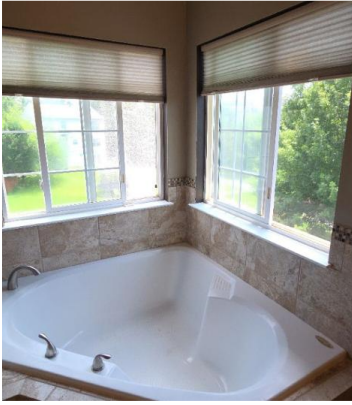
Caulk around tub surround is old and deteriorated. This can allow water infiltration and deterioration of framing around the tub. Recommend removing old caulk around tub and apply new caulk.

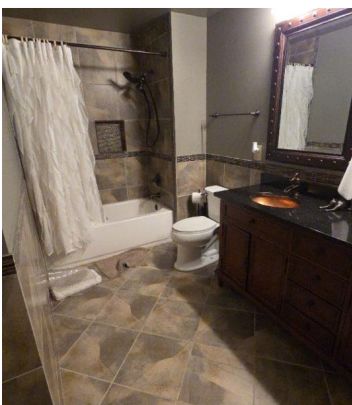
Door to bathroom rubs against tile

The bottom of the door to the bathroom indicated in the photo location rubbed the tile floor when opened. Possible from new tile instillation. Recommend checking with a contractor to undercut the door slightly as well as ensuring the tile floor is properly level.

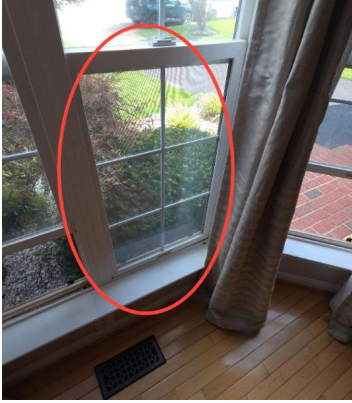
## Window broken or damaged

The window in the front room in the photo was misaligned within it's enclosure and did not function properly at the time of the inspection. Recommend correction by a window contractor.

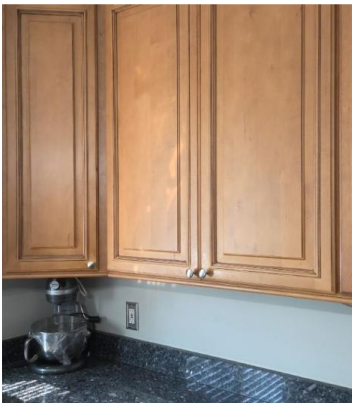
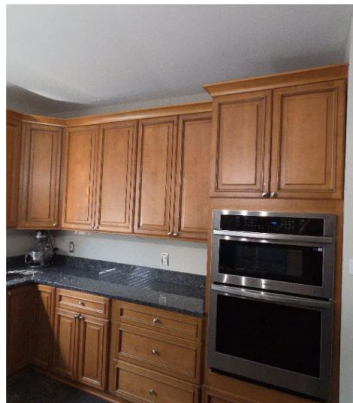
Cabinet door hinge(s) needs tightening/adjustment or replacement.

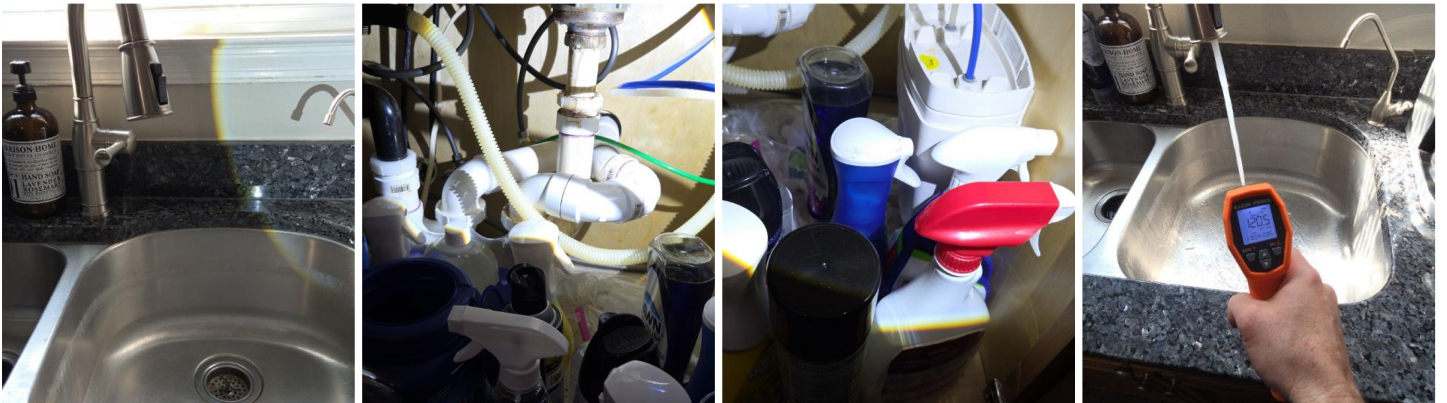
Plumbing Drainpipe – possible previous leak

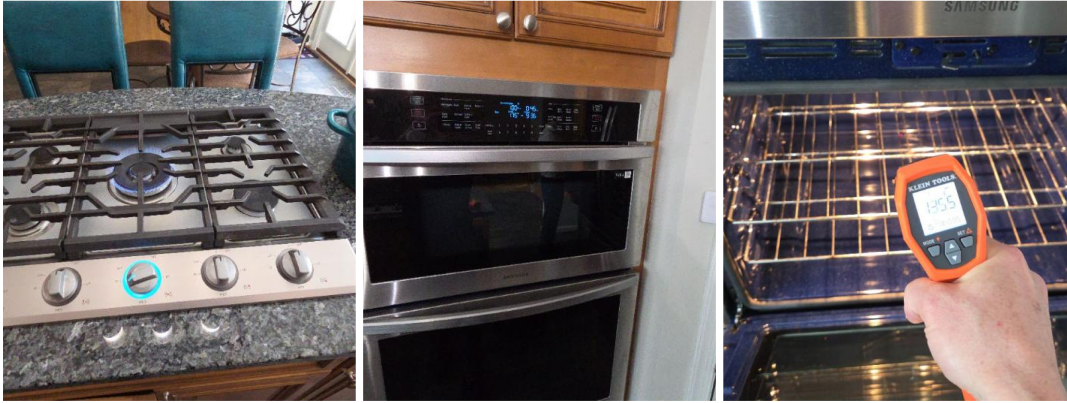
No exhaust

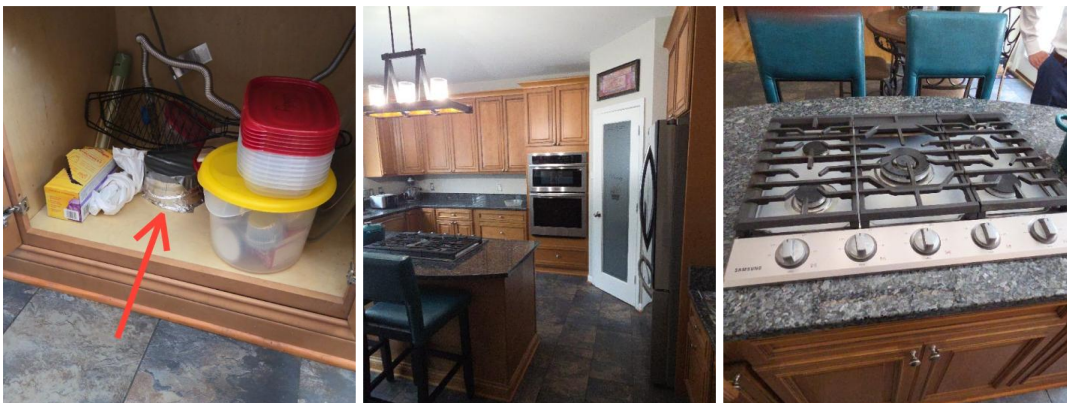
No exhaust ventilation for gas cooktop observed

A dedicated exhaust ventilation system was not observed above the gas cooktop at the time of the inspection. Although not required in all homes, exhaust ventilation is recommended to help remove heat, moisture, grease, and combustion byproducts generated during cooking. Consider installing a vented range hood that exhausts to the exterior if one is not present. A 'roughed-in' pipe was present in the cabinet under the cooktop.

Safety Concern

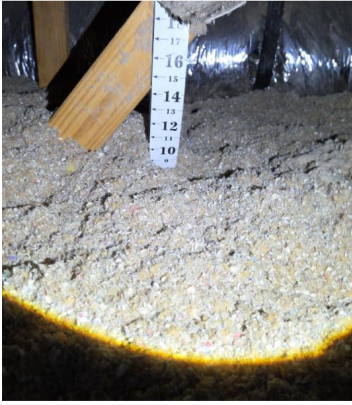
The insulation was 12" in the majority of the attic. It was 10" close to the access hatch.

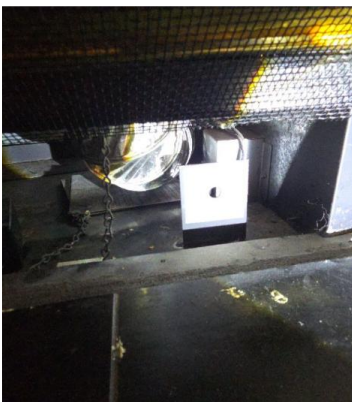
Gas Fireplace Not Tested – Control missing or inoperable

The indicated gas set could not be tested at the time of the inspection because the unit's dial to control gas flow was missing. The pilot light was on. Recommended repair by a licensed gas contractor.

Requires Attention

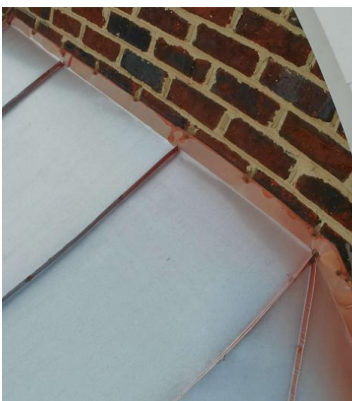
The front porch was roofed with a style of metal roofing commonly known as “standing seam” metal roofing. A standing seam metal roof typically has a lifespan of 40 to 50 years, whereas an exposed fastener metal roof typically has a lifespan of 20 to 25 years. This metal is currently bare and can rust if not periodically painted with a quality exterior paint.

Maintenance

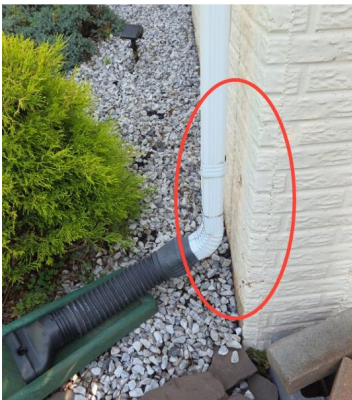
Downspout component Loose

The indicated section of downspout was loose. (Location detailed within the report photos) It is recommended that the loose downspout section be repaired or secured as needed by a qualified contractor.

Requires Attention

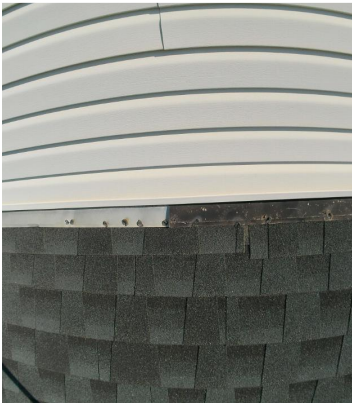
Metal flashing was present at the roof-to-wall intersection on the front of the house above the garage. Exposed fasteners were observed in the flashing. Recommend maintaining sealant at exposed fasteners to help reduce the potential for moisture intrusion or repair by licensed roofing contractor.

Maintenance

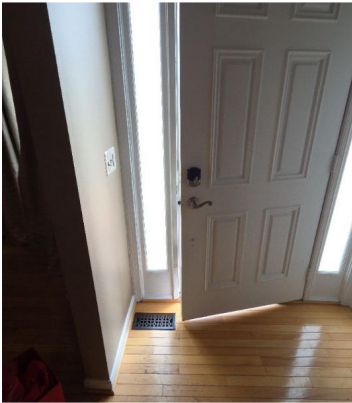
Location - Front door

The indicated exterior door was binding on the door frame and as a result would not open and close properly. It is recommended that a qualified contractor make the necessary repairs or adjustments needed to allow the door to open/close properly.

Requires Attention

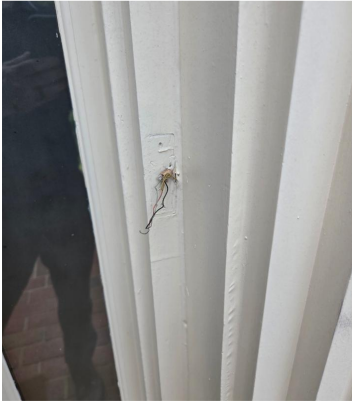
Hardwired doorbell has exposed wires. Located next to a smart doorbell. Low voltage current but recommend correcting by contractor.

Requires Attention
